Site Summary Group J

AREA IV

Santa Susana Field Laboratory, CA

Site Summary – Building 4023

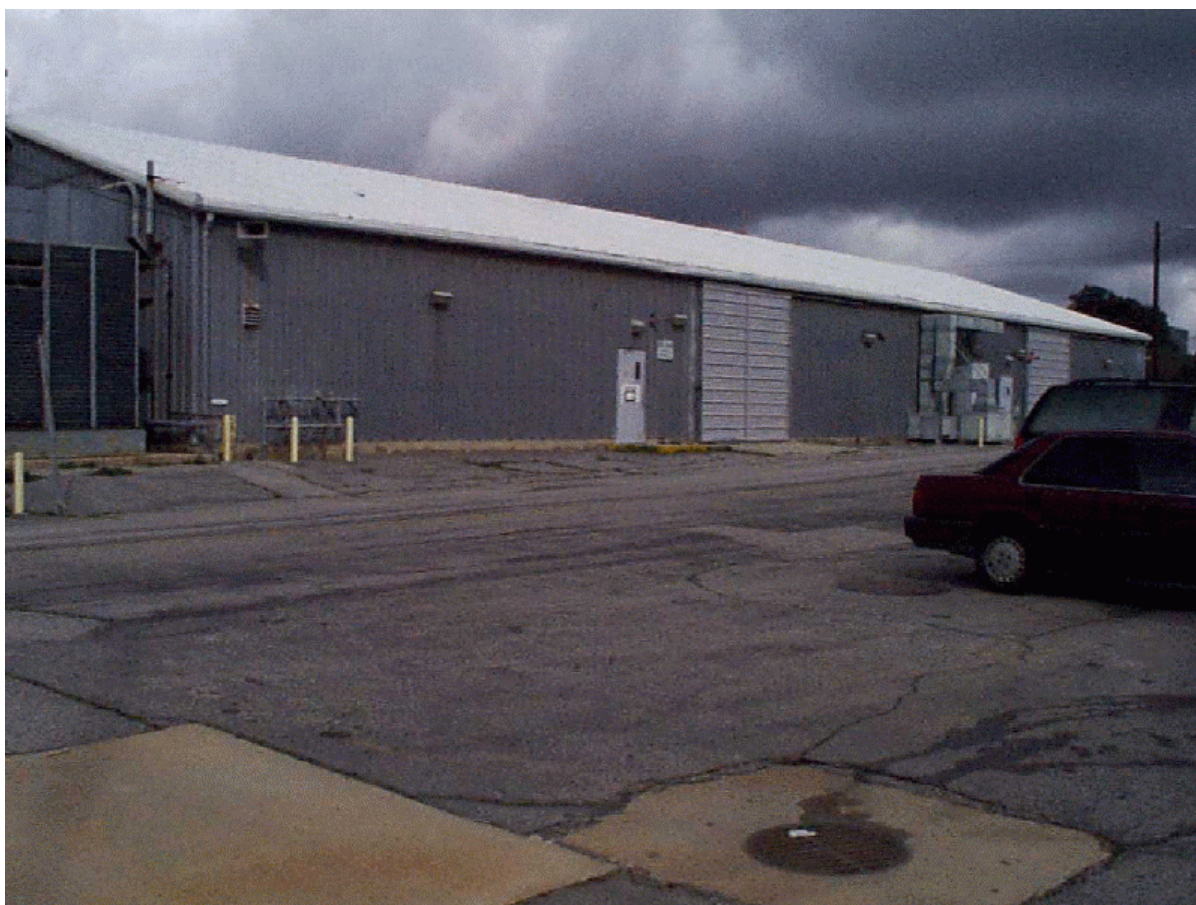
Photograph – Building 4023

- Building 4023 was a single story structure with galvanized steel walls and roof and a concrete slab floor. The sodium test loop was located in the western, or “old,” portion of the building. The “new” building section held an analytical chemistry laboratory and a storage set-up room.³
- The facility was approximately 20 feet below the general grade of the adjacent 12th Street.¹
- The waste holdup tank was located in an exterior sub-grade open-top concrete vault (7.5 feet x 10 feet x 6 feet) at the east end of Building 4023.²
- Serviced by Substation 4742.

- The majority of the contamination of Building 4023 was associated with drain lines and associated vent pipes, the holdup tank, the open top holdup tank pit, and a laboratory fume hood.⁴

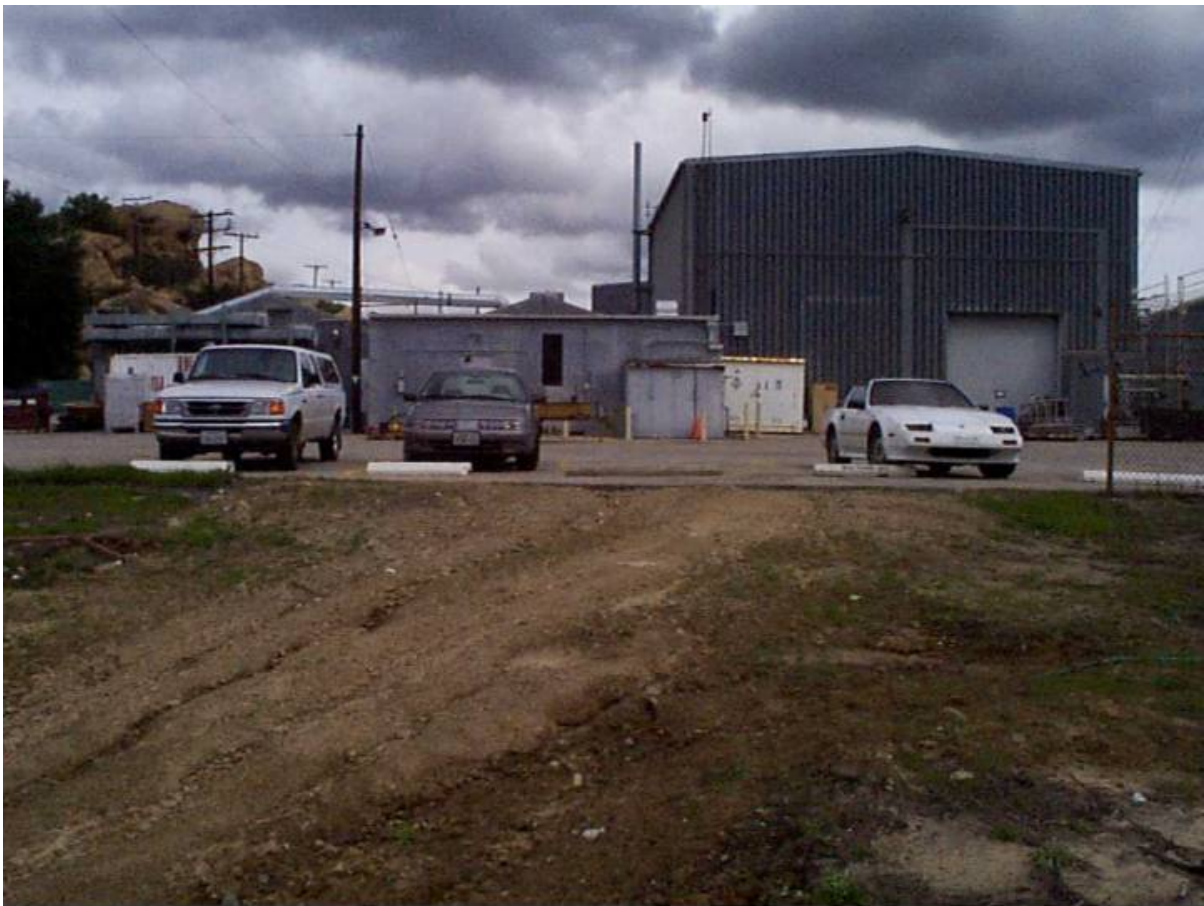
Photograph – Building 4024

- Building 4024 consists of two levels, one at ground level and a sub-grade basement.²
 - The areas within (and associated with) Building 4024 included: a high bay, including cell complex and operating gallery, a general support and operating area, a mechanical/electrical support area, and a yard.

- Building 4024 is constructed of aluminum siding, steel framing, some flooring and concrete.²
- The basement consists of a cell complex with two power test cells and a cell-transfer lock. This complex is constructed of shielded concrete walls ranging from two feet to nine feet thick, penetrated by various through-tubes, conduits and cooling pipes.¹

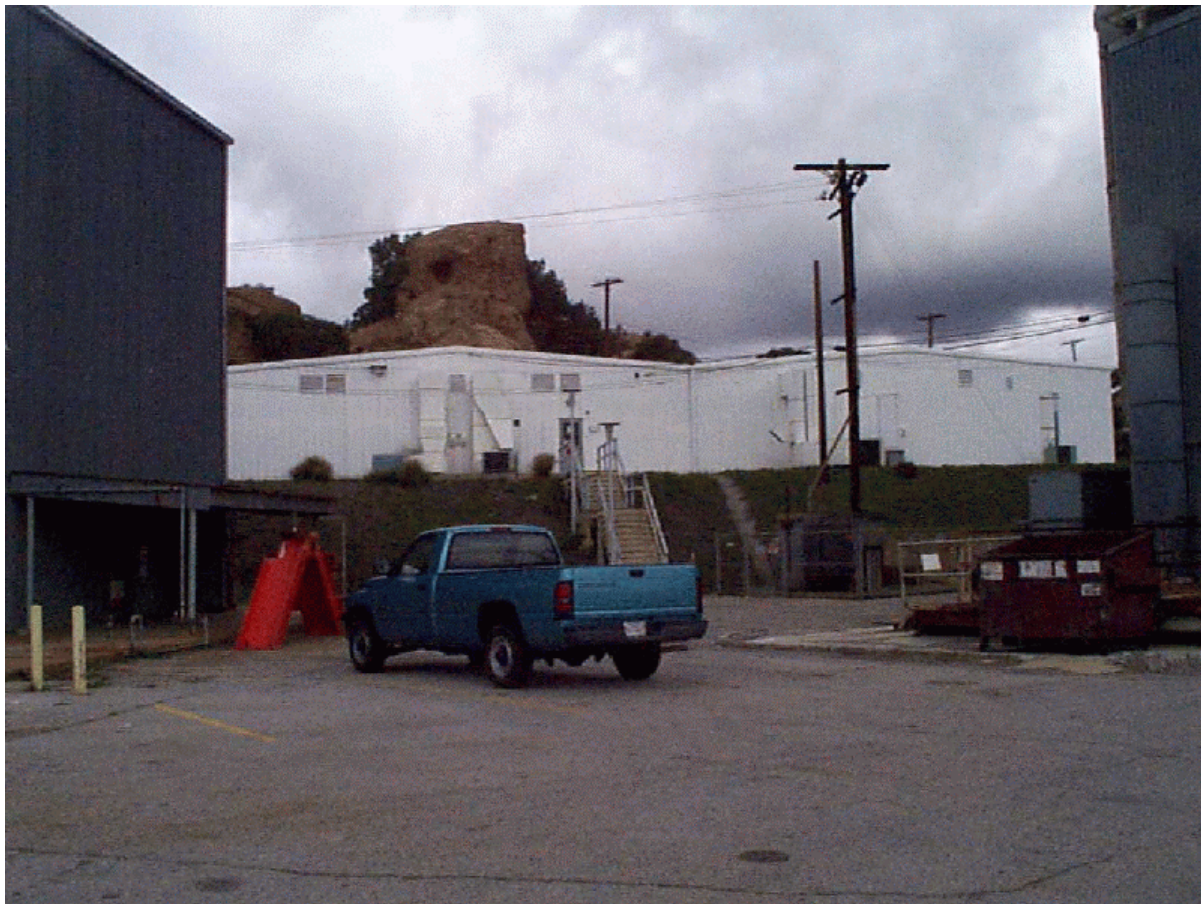
Photograph – Building 4036/4037

- Building 4036/4037 consisted of two one-story metal buildings joined together, each with a concrete slab floor and concrete foundation. The support structure consisted of steel beams with corrugated steel siding and roof. The buildings contain numerous internal partition walls with wood framing and drywall surfaces.²
- Serviced by Substation 4727.

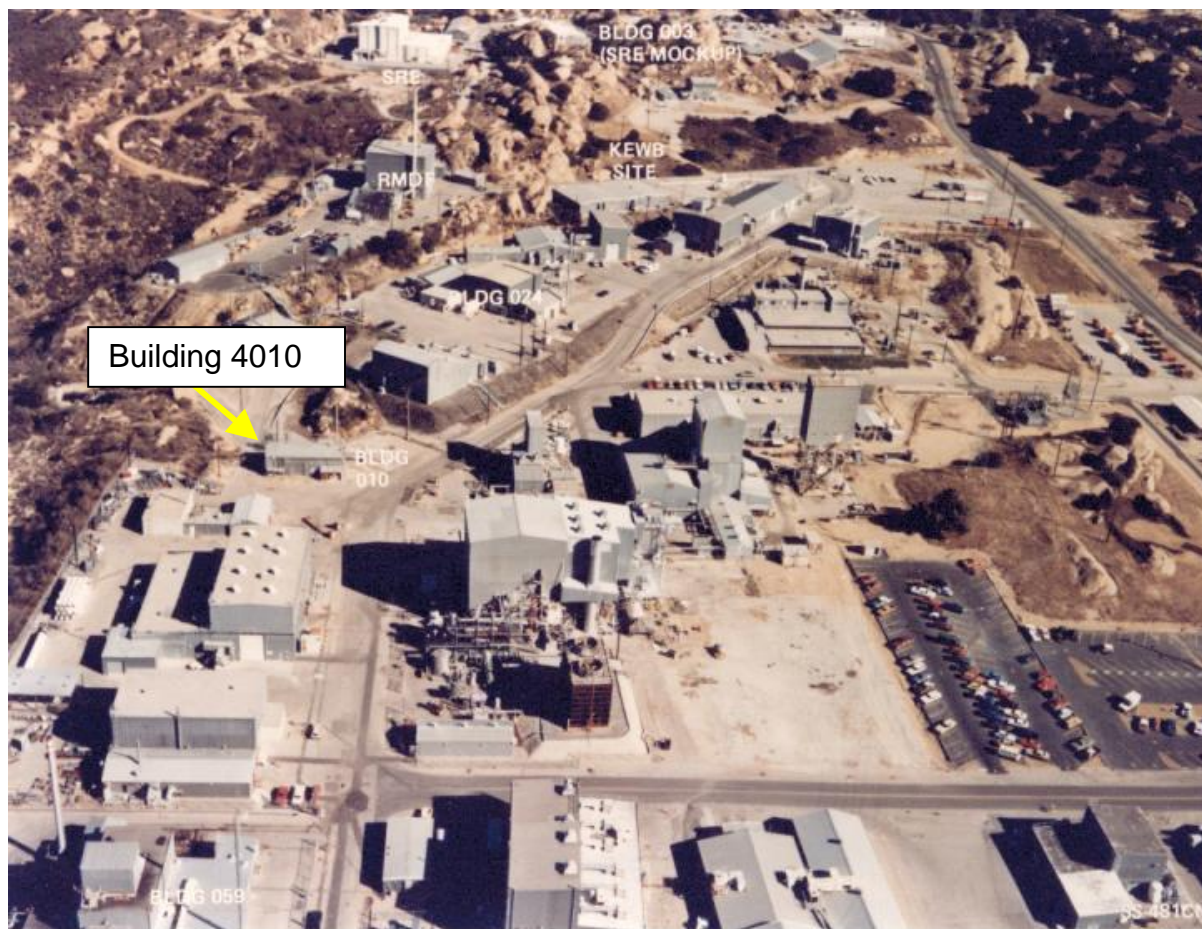
Photograph – Building 4010

- Building 4010 was eventually abandoned in place; it was later removed.⁵
- The entire vault complex was provided with a sub-foundation drainage system consisting of circuits of perforated metal pipe surrounded by gravel fill. The system drained into a pipe well sump at the east end of the building. From the sump, water was pumped into a tank for controlled disposal if contaminated, or released to the surface drainage system if it tested clean.¹

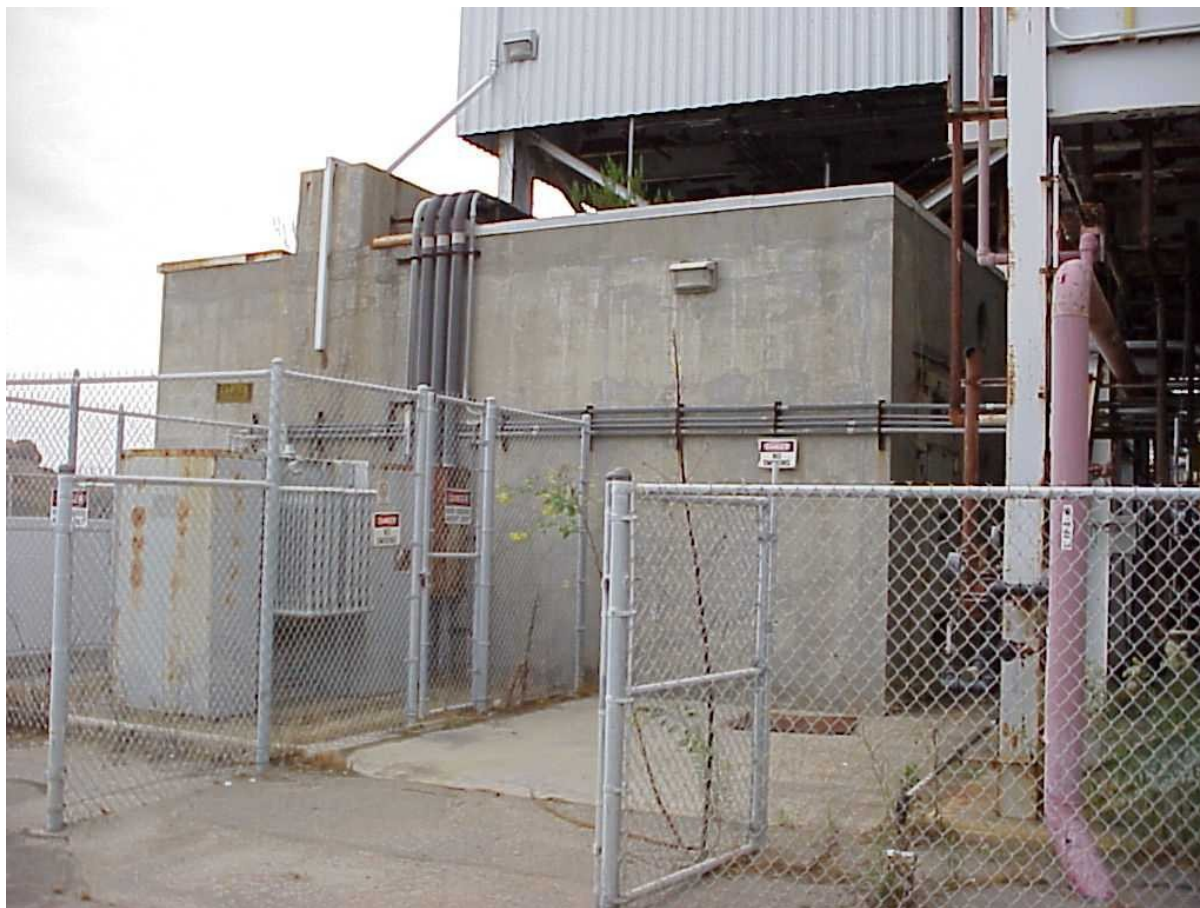
Photograph – Building 4012

- Building 4012 had 1,292 square feet of floor space. In 1986, the passageway and metal portion containing the operations and control rooms of Building 4012 were demolished in order to build the ETEC Sodium Component Test Installation (SCTI) Power Pak section of the Cogeneration Project.¹
- The remaining concrete vault consisted of two rooms, Room 109 (fuel storage/equipment room) and Room 110 (critical cell). A 20-inch borated concrete wall containing fuel storage tubes divided Room 109. An air conditioning duct ran the length of the room over the fuel storage area.
- The critical cell (Room 110) was a concrete chamber with 4-foot thick concrete walls lined with steel and was secured by a heavy shield (vault-type) door.¹
- Serviced by Substation 4713.
